FINAL ROUND 10 DAM ASSESSMENT REPORT NIPSCO BAILLY GENERATING STATION COAL ASH IMPOUNDMENTS

AUGUST 17, 2012

Re: Round 10 Dam Assessment - Final Report
EPA Contract No. EP10W001313
NIPSCO Bailly Generating Station
Coal Ash Impoundments
Chesterton, Indiana

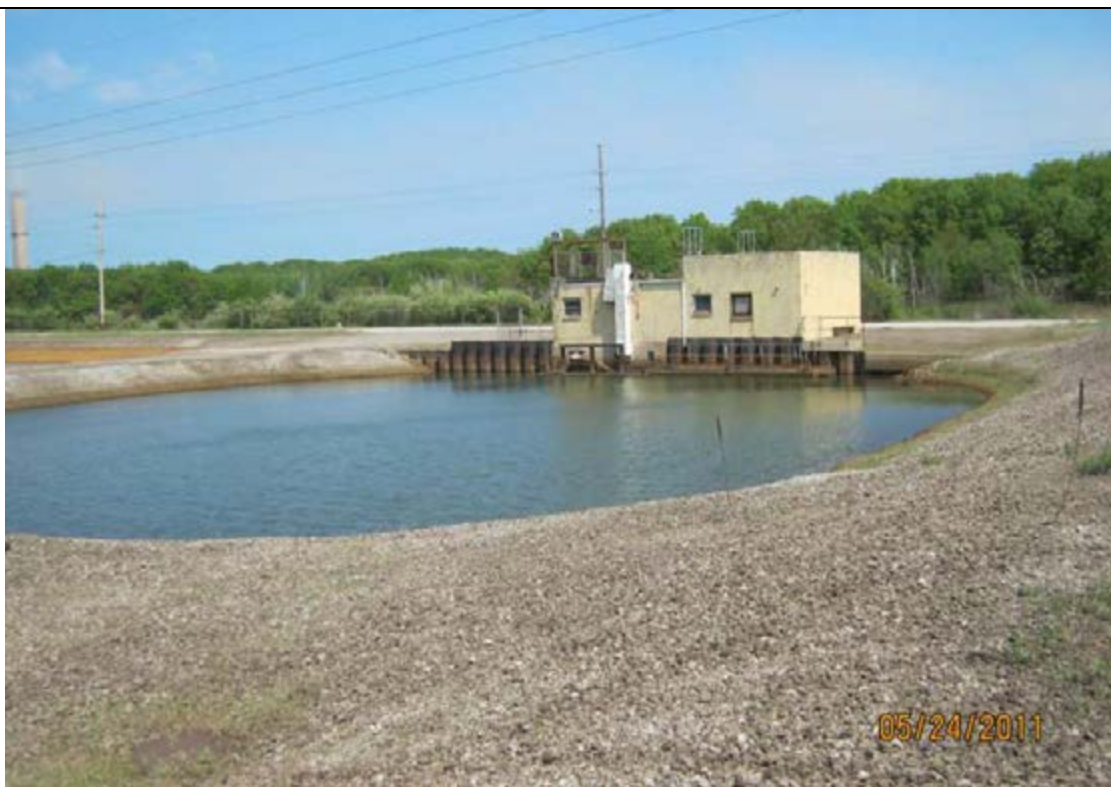
Photo No.
26

Forebay and Recycle Water
Pumphouse.

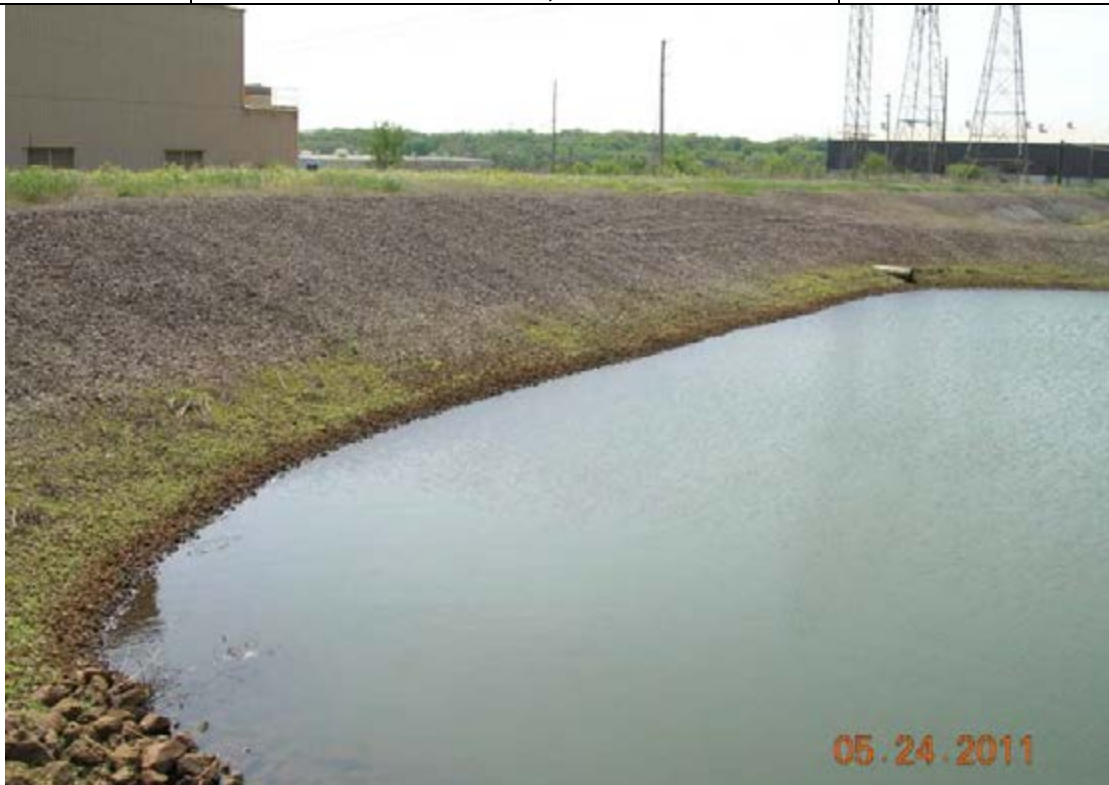
East embankment of the
Forebay. The vacant
wastewater treatment
building is on the left side of
the photograph.

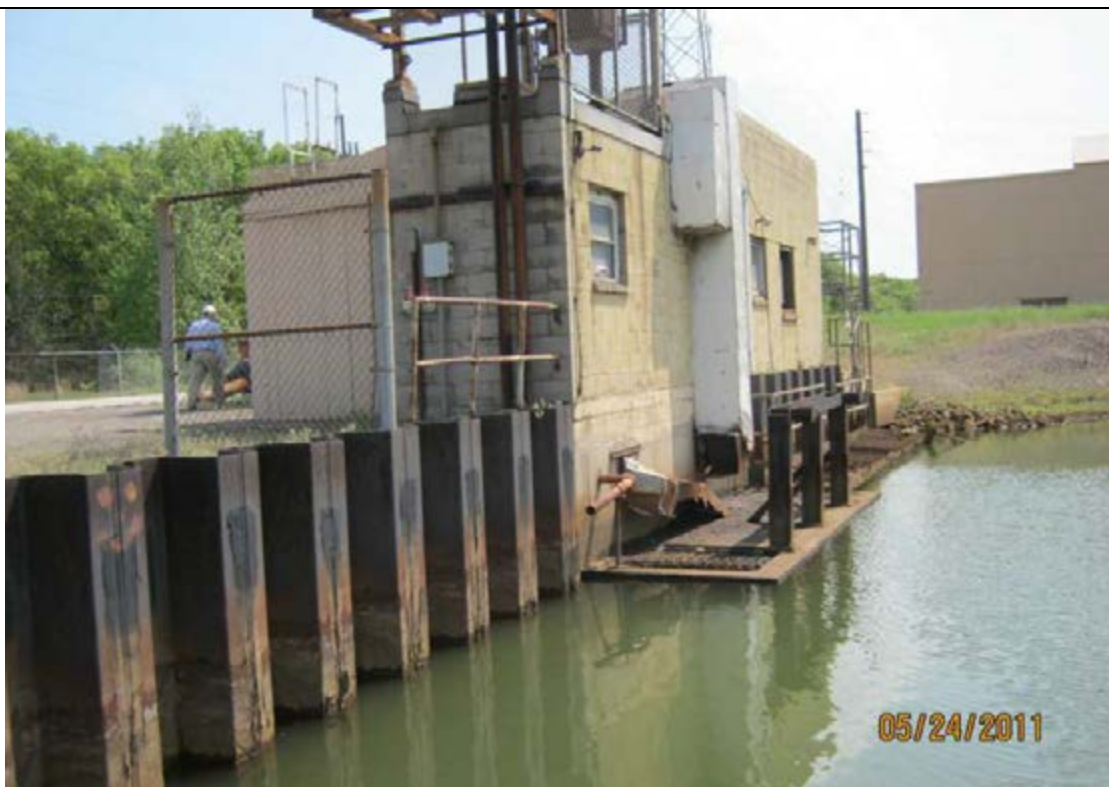
Photo No.
28

Recycle Water Pumphouse.

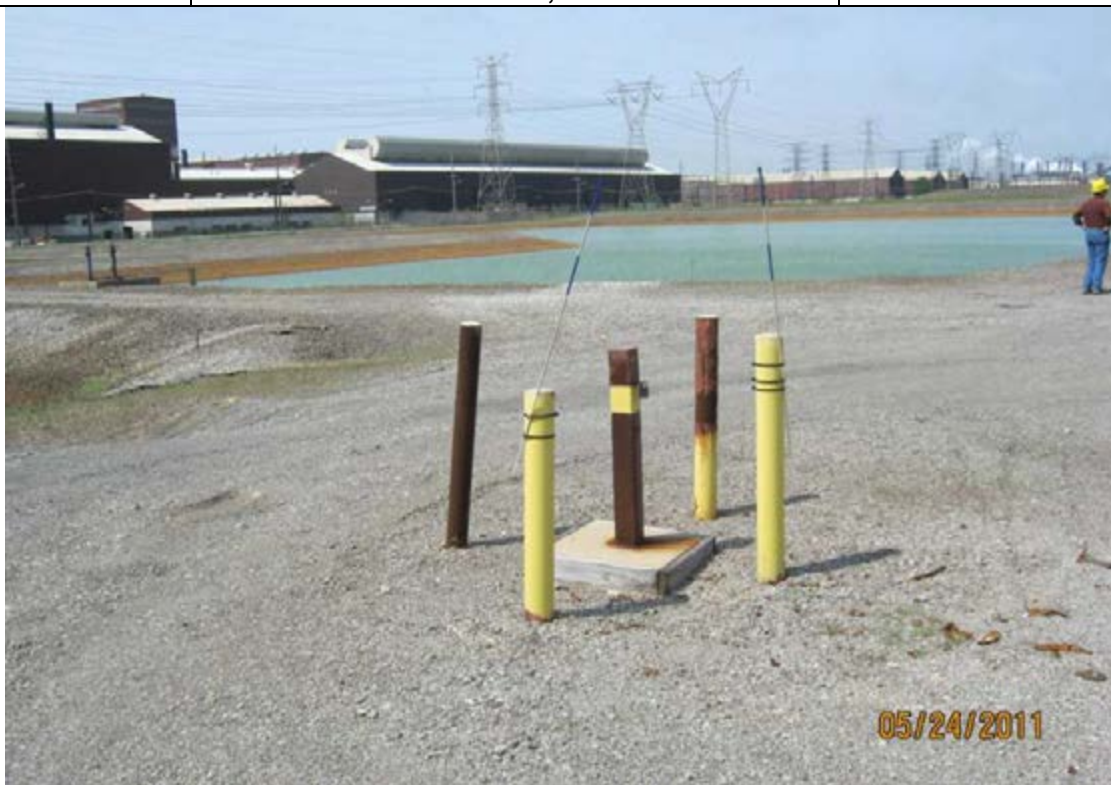
Description:
Groundwater monitoring well near the Forebay.

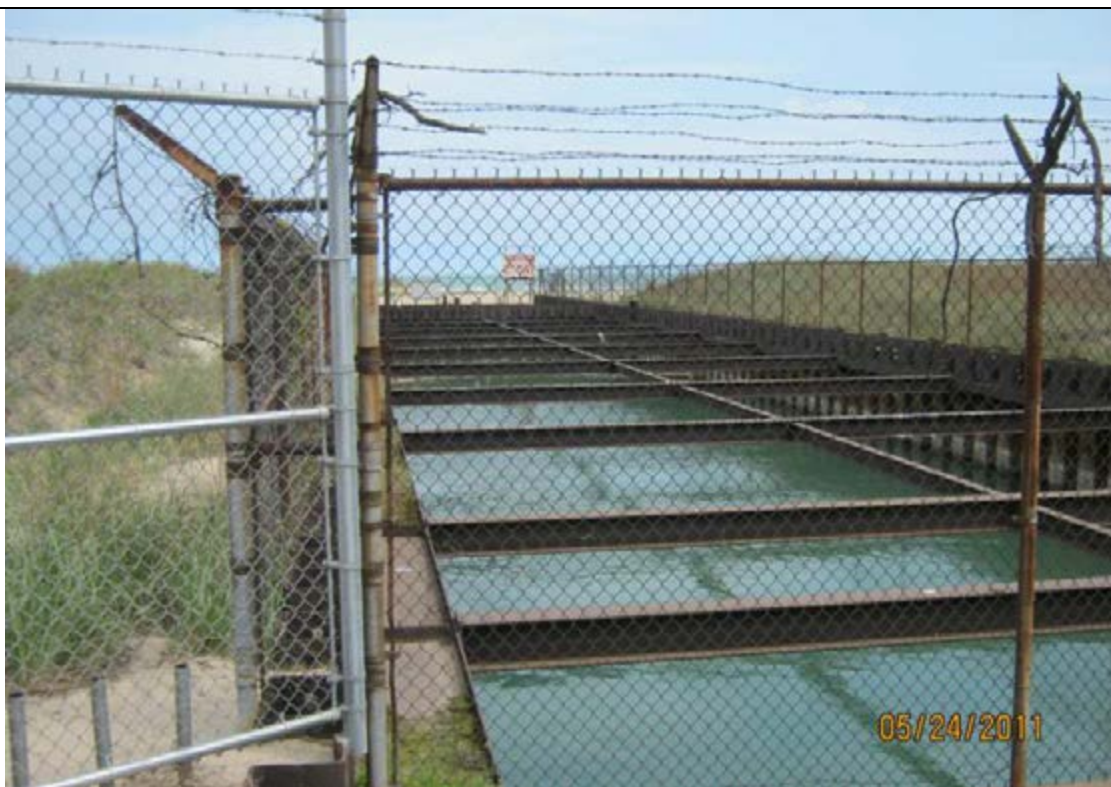
Photo No.
30

Description:
NPDES outfall to Lake Michigan.
